# **INDOOR AIR QUALITY REASSESSMENT**

**Division of Capital Asset Management and Maintenance  
One Ashburton Place, 15<sup>th</sup> floor (southwest corner)  
Boston, MA**

Prepared by:  
Massachusetts Department of Public Health  
Bureau of Environmental Health  
Indoor Air Quality Program  
May 2018

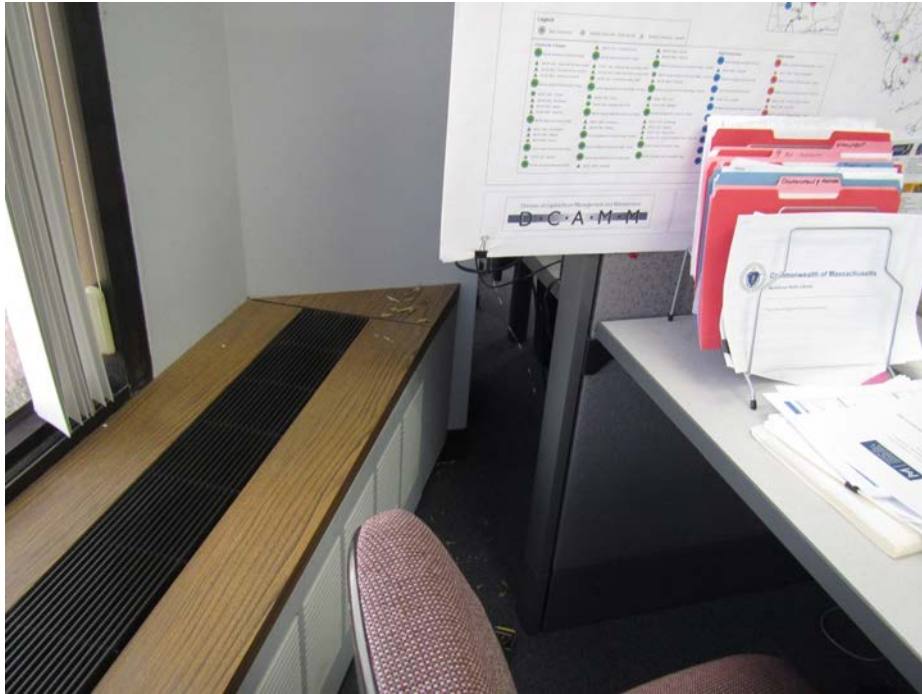
**Picture 1**

Fresh air is supplied by induction units located along the outer edges of the building (Picture 1) and supply vents located in the ceiling (Picture 2). Return air is drawn through ceiling-mounted grates or around light fixtures using ducted returns. Some induction units had items on top of them, which can obstruct the flow of fresh air. In addition, some of the items on/near the vents of the induction units can be a source of dusts, odors and, in the case of plants, pollen, and other potential allergens. Induction unit vents should be kept free of items and kept clean.

**Induction unit next to window, note plant debris**

3. Regularly clean induction unit fins and condensation pans (if any) to reduce accumulated debris.
4. Remove items from the top and front of induction units to allow for air flow.

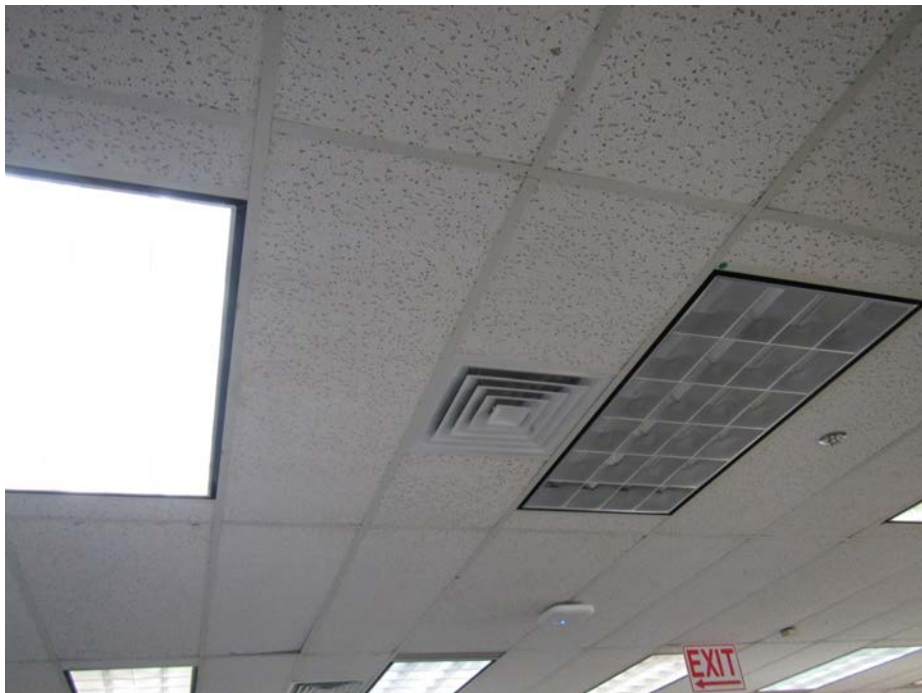
**Picture 2**

**Typical supply vent and area around lights used as return**

11. Clean supply vents, personal fans and other equipment to prevent aerosolizing dust.
12. Clean carpeting in accordance with IICRC recommendations (IICRC, 2012). Consider the use of plastic chair mats under desks to protect carpeting.

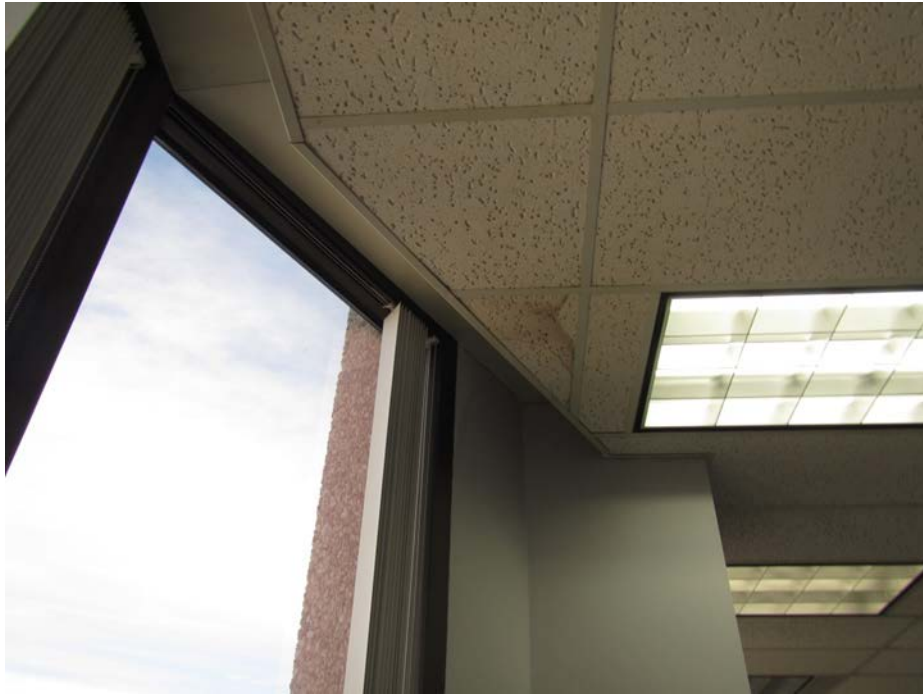
**Picture 3**

A water-damaged ceiling tile was observed along the window (Picture 3). Due to the age and condition of the building, water leaks near the windows have occurred in this building during wind-driven rain events. Water-damaged ceiling tiles should be replaced when discovered. In addition, staff should avoid storing porous items (e.g., paper, boxes) in areas where leaks have occurred in the past.

**Water-damaged ceiling tile next to window**

5. Replace water-damaged ceiling tiles. Avoid storing porous items in areas where leaks occur.
6. Keep plants in good condition, avoid overwatering, and remove from the airstream of heating and ventilation equipment. Consider reducing the number of plants in this area.

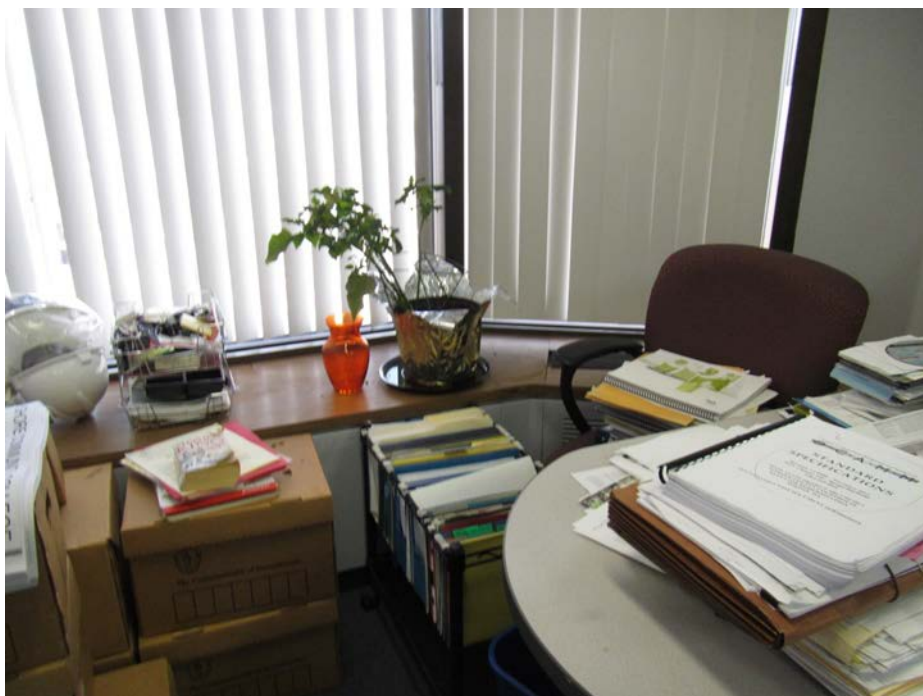
**Picture 4**

Plants were noted in a few areas (Table 1; Pictures 4 and 5). Plants can be a source of pollen and mold, which can be respiratory irritants to some individuals. Plants should be properly maintained and equipped with drip pans and should be located away from induction units to prevent the aerosolization of dirt, pollen, and mold.

**Plant in office, note items and boxes on floor**

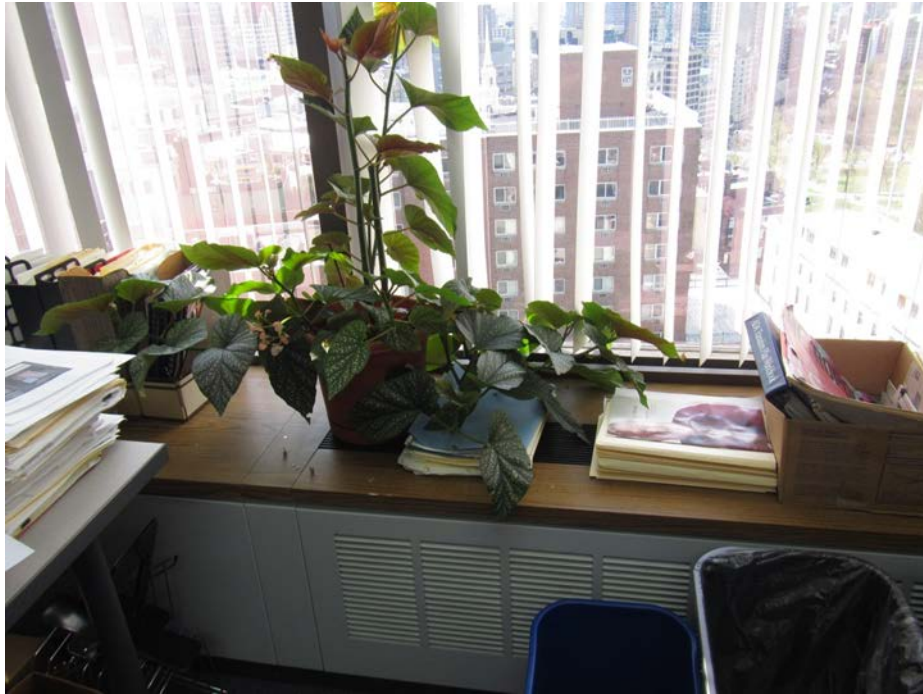
**Picture 5**

Items were observed on a number of flat surfaces, such as windowsills, tabletops, counters, bookcases, and desks (Pictures 5 and 7). Items stored in offices provide a source for dusts to accumulate. These items (e.g. papers, folders, boxes) also make it difficult for custodial staff to clean. Items should be relocated and/or be cleaned periodically to avoid excessive dust build up. Some supply vents and personal fans were observed to be dusty. Dust should be cleaned periodically to prevent aerosolization when the equipment is activated.

**Plants on induction unit and items blocking unit airflow**

9. Reduce the use of scented cleaning products, sanitizers, and other items that contain VOCs.
10. Reduce the amount of items stored on flat surfaces to allow regular cleaning.

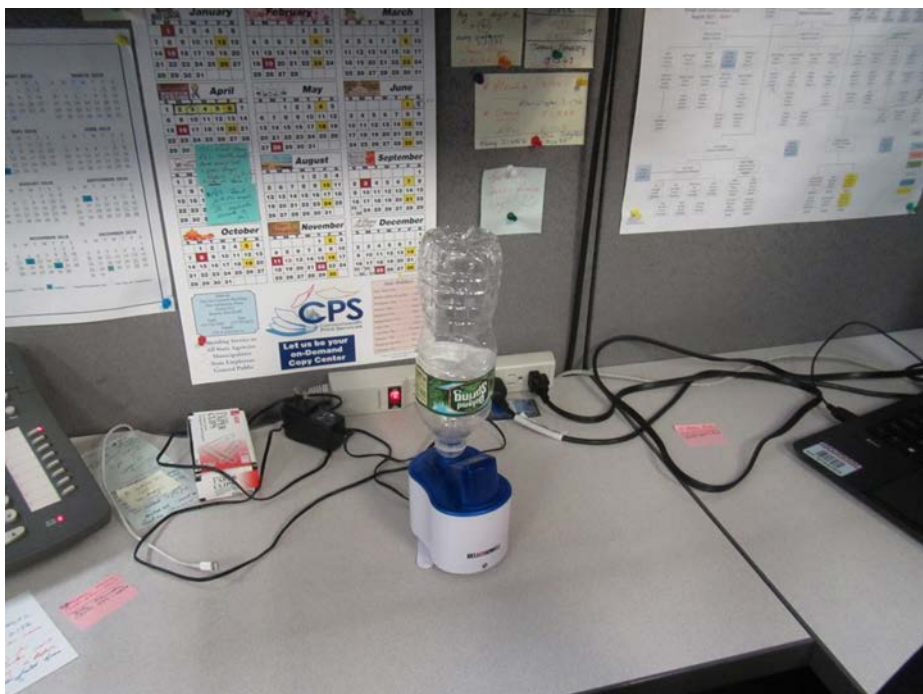
**Picture 6**

A miniature humidifying unit was observed in one area (Picture 6). While low relative humidity is typical during the winter months and can lead to common symptoms such as dry skin, dry eyes, and respiratory tract irritation, the use of humidification devices is not typically

recommended in an office environment. Humidification units need to be kept scrupulously clean or they can become a source of microbial contamination and odors. Spills, leaks or condensation caused by these units can also be a source of moisture to porous materials. To reduce the potential for symptoms, scrupulous cleaning practices should be adopted to minimize common indoor air contaminants whose irritant effects can be enhanced when the relative humidity is low. To control for dusts, a high efficiency particulate arrestance (HEPA) filter equipped vacuum cleaner in conjunction with wet wiping of all surfaces is recommended. Drinking water during the day can help ease some symptoms associated with a dry environment.

**Miniature humidifier**

7. The use of humidification devices in offices is not recommended. If they are used, ensure they are kept clean to prevent microbial colonization and odors, and that they are not placed on porous surfaces.

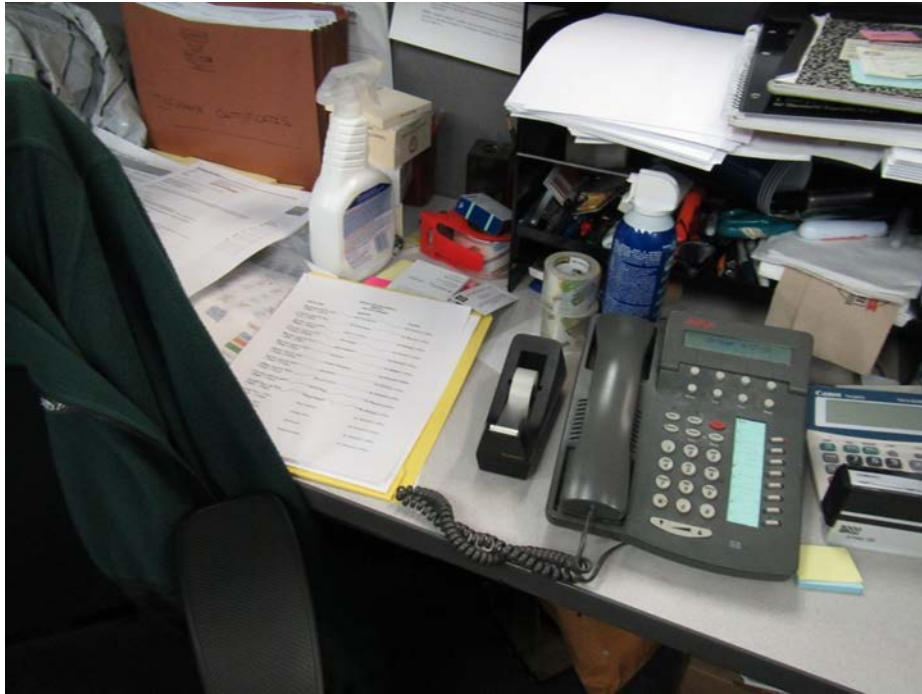
**Picture 7**

Exposure to low levels of total volatile organic compounds (TVOCs) may produce eye, nose, throat, and/or respiratory irritation in some sensitive individuals. In addition to testing, BEH/IAQ staff examined spaces for products containing VOCs. BEH/IAQ staff noted air fresheners, hand sanitizers, cleaning products, and dry erase materials in the office space (Picture 7; Table 1). All of these products have the potential to be irritants to the eyes, nose, throat, and respiratory system of sensitive individuals.

**Cleaning products, markers and items on flat surfaces**

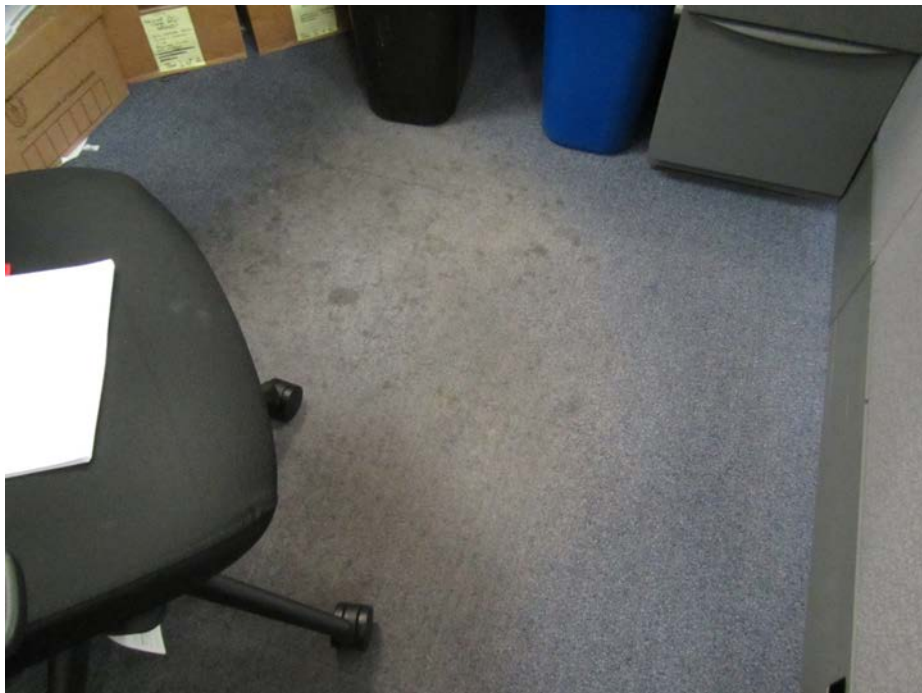
**Picture 8**

The offices were mostly carpeted. Carpets should be cleaned annually (or semi-annually in soiled/high traffic areas) in accordance with Institute of Inspection, Cleaning and Restoration Certification (IICRC) recommendations, (IICRC, 2012). Some carpeting was observed to be stained and worn, especially under desks (Picture 8). The use of plastic desk chair mats may help prevent damage to carpeting

**Stained, worn carpeting under desk**
